Manhole Inspection Summary

Manhole # S67I__006MH

Insp Date: **3/1/08 8:56 AM**

Location Address: **500 Dundalk Ave.**

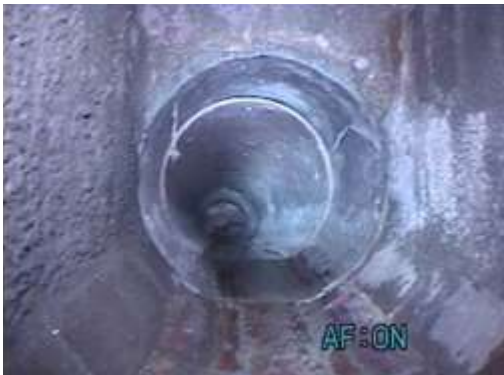
Defect 1

Crack longitudinal 3:00. incoming 3 O'Clock pipe

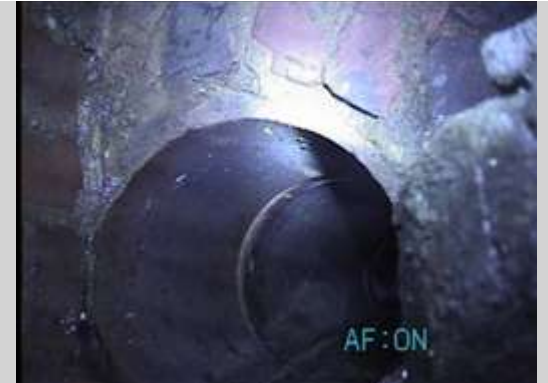
12 O'Clock Outflow

10 in. Circular Gravity Sewer
Pipe Out @ 12 O'Clock

Pipe Height: **10.8** (in.) Rod and Bar (Angled)
Pipe Material: **Clay** ☐ Pipe Lined
Invert Depth: **9.67** (ft.) Flow Characteristics: **Fast**
Deposits: ☒ None ☐ Mud ☐ Sludge ☐ Debris ☐ Grease
Silt Depth: (in.) Deposits Extent:
Infiltration: **None** Pipe Seal Cond: **Sound**

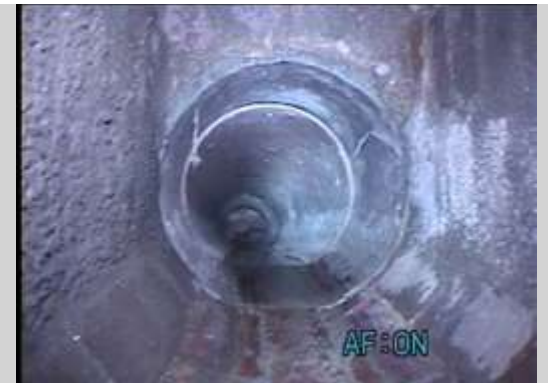
3 O'Clock Inflow

10 in. Circular Gravity Sewer
Pipe In @ 3 O'Clock

Pipe Height: **9.6** (in.) Rod and Bar (Angled)
Pipe Material: **Clay** ☐ Pipe Lined
Invert Depth: **9.00** (ft.) Flow Characteristics: **Fast**
Deposits: ☒ None ☐ Mud ☐ Sludge ☐ Debris ☐ Grease
Silt Depth: (in.) Deposits Extent:
Infiltration: **None** Pipe Seal Cond: **Sound**
